NRL Memorandum Report 4128

## Shock and Vibration Performance of an Epoxy Chocking Compound

December 7, 1979

NAVAL RESEARCH LABORATORY  
Washington, D.C.

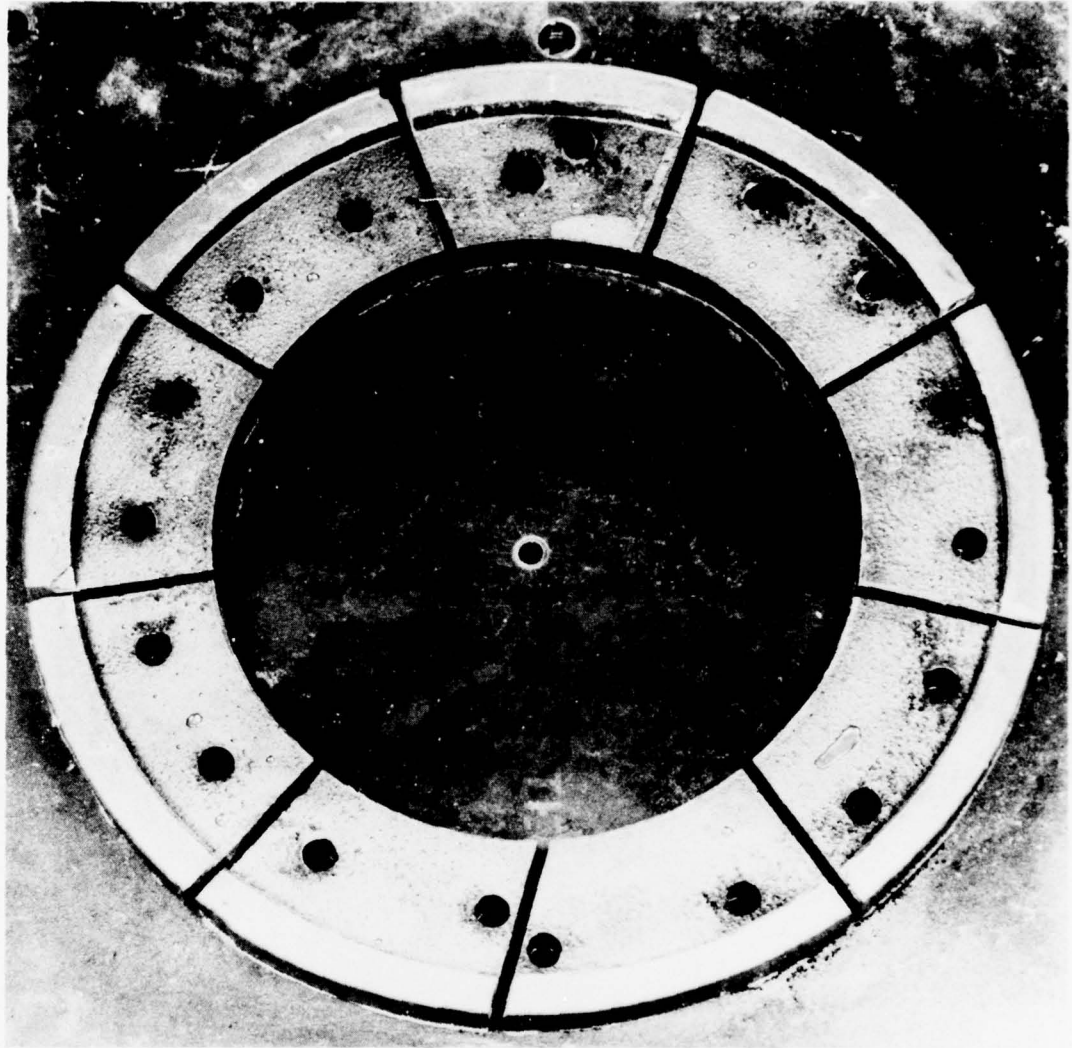
Following the vibration test, the test assembly was taken apart for inspection of the chocks. As may be seen in Figure 9 (top) and Figure 10 (bottom), no change was found in their condition, save that their bearing surfaces were somewhat grimmer. The test assembly was then put back together and mounted on the MWSM for shock tests.

Fig. 9 — Top surface of the chock pads of Test Structure No. 1  
following vibration test

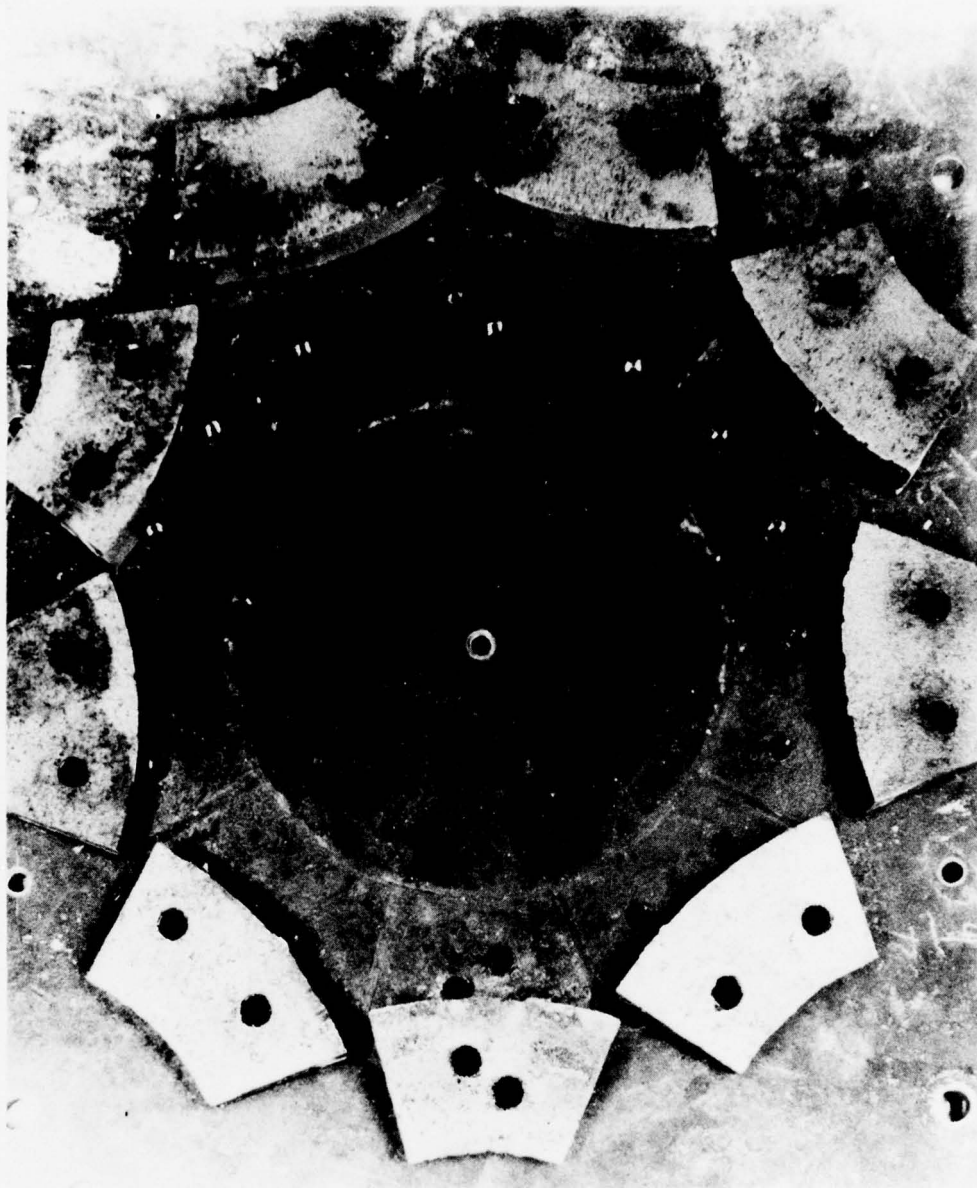
Fig. 10 — Bottom surface of the chock pads of Test Structure No. 1  
following vibration test

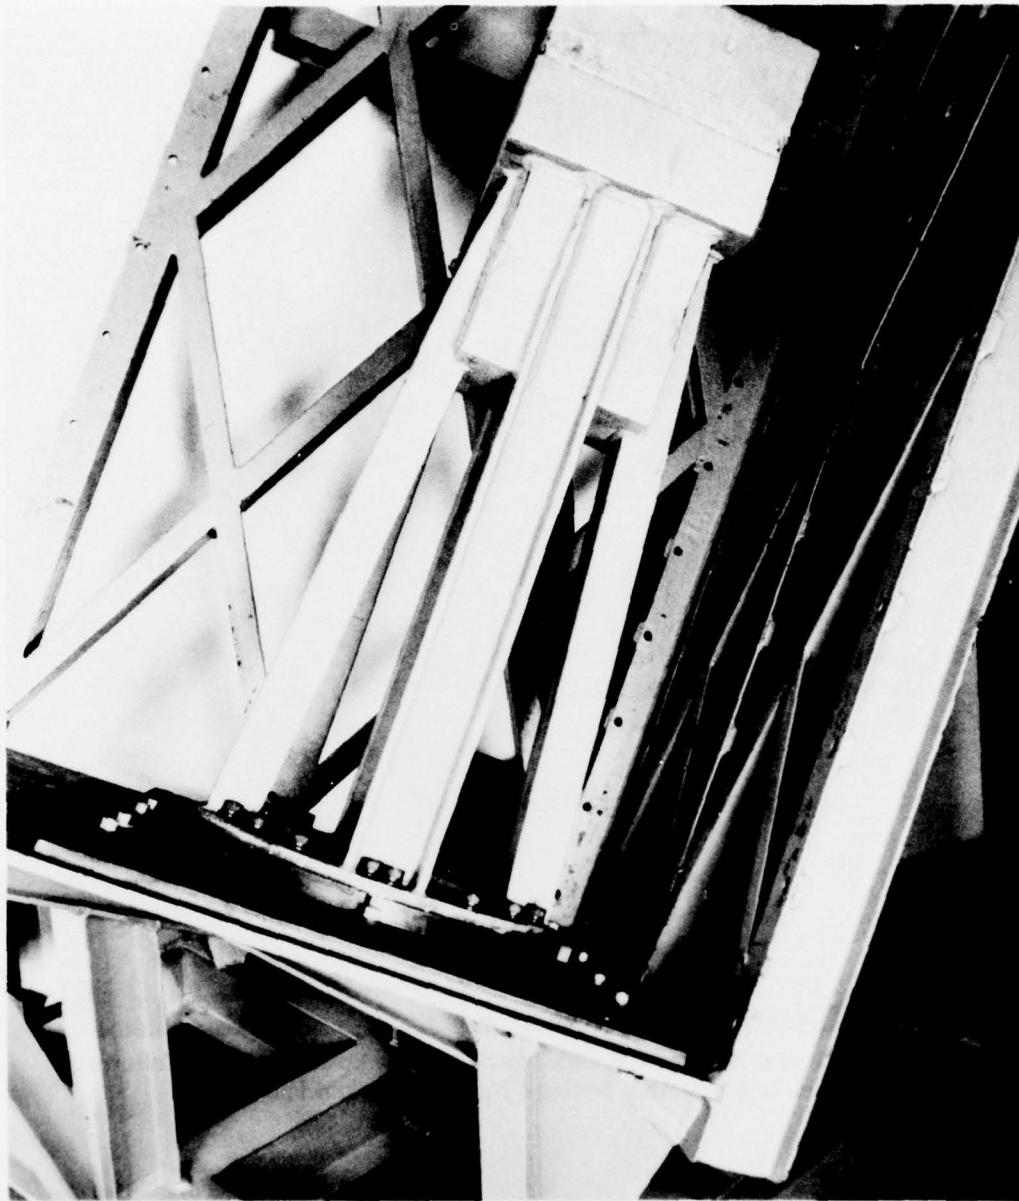
It was observed that the overpour ridge of Pad No. 3 at the end adjacent to Pad No. 4 had moved outward from the edge of the mounting ring. Closer inspection revealed a crack in the bearing section of Pad 3 at this end just outside the mounting bolt. No similar crack was found at the other end of the pad, but as the overpour was visibly separated from the edge of the mounting ring for a third or more of its length, it would be safe to assume that the observed crack extended at least as far.

In this blow, the overpour and a small section of the load-bearing portion of Pad 3 slipped completely out from under the mounting ring. As shown in Figure 13, it slid down until it was stopped by the row of bolts used to attach the mounting plate to the 30°-Corner Bulkhead.

Fig. 13 — Damage from shock. After the regular shock test of Test Structure No. 1 had been completed, two additional blows were delivered with the mounting bolts loosened. A section of Pad No. 3 broke off and slid out from under the mounting ring. It may be seen resting against the heads of the row of bolts securing the mounting plate to the 30°-Corner Bulkhead.

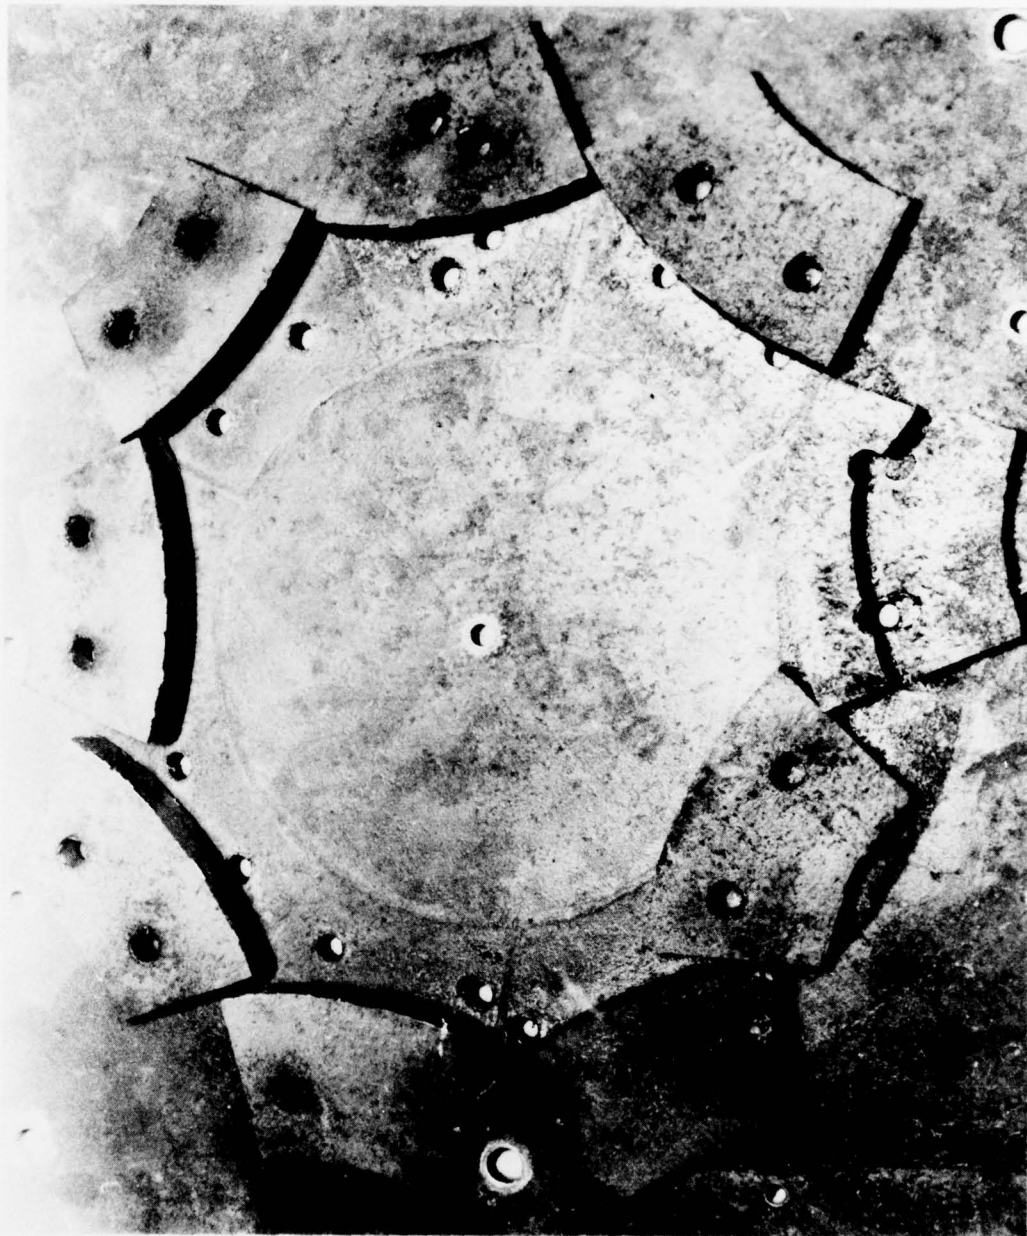
The test assembly was then removed from the MWSM and disassembled. The top and bottom views of the chocks are shown in Figures 14 and 15, respectively. As may be seen, the loss of the broken-off portion of Pad No. 3 did not entail much reduction in its load bearing area, and would not have impaired alignment of the mounted item. Note, however, that while the circumference of one bolt hole (the upper in Figure 14) is substantially intact, that of the other is about half gone. As it exists, this crack might allow the remaining portion of the pad to pivot on the upper bolt until its ends bound against those of the adjacent pads, which would cause little additional loss of bearing area and still no effect on alignment. A slightly different crack trajectory could easily have split both bolt holes, and perhaps allowed the pad to be lost completely. Given the overall chock configuration, it is questionable if even this event would lead to significant loss of bearing area or alignment in practical situations.

Fig. 15 — Bottom surface of the chock pads of Test Structure No. 1 after shock and vibration testing

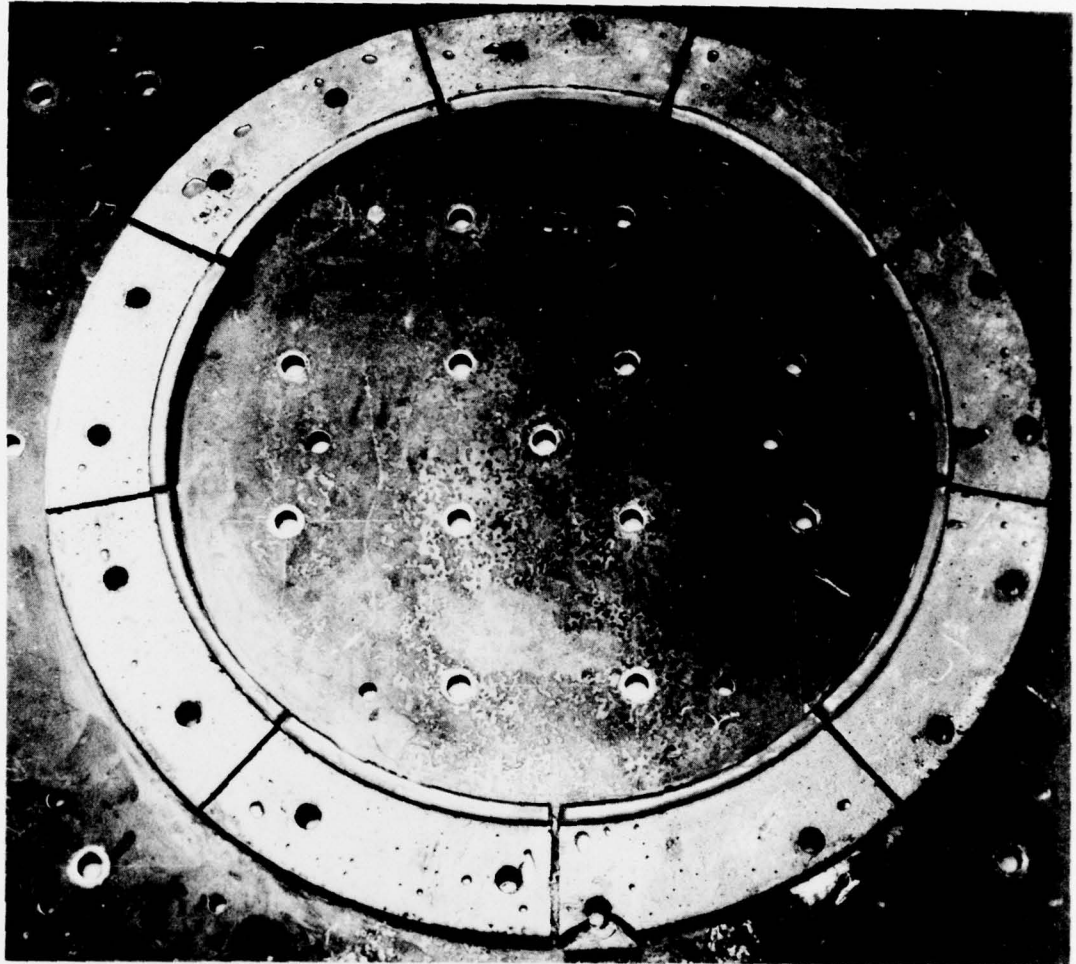
For this blow, the mounting bolts were loosened completely, then tightened finger-tight. With this condition, a triangular segment chipped out of Pad No. 2 from the outside of the bolt-hole adjacent to Pad No. 3 (Figures 23, 24).

The test assembly was then taken apart and the top (Figure 23) and bottom (Figure 24) surfaces of the chock pads photographed. With the exception of the small piece chipped out of Pad No. 2, the condition of the pads seems little changed by the shock test. The

damage noted would cause a miniscule decrease of load-bearing area, and would not be likely to impair alignment of a mounted item. The affected pad conceivably could rotate about the bolt through the intact hole, but with this chock pad configuration could do so only to a small degree.

Fig. 23 — Top surface of chock pads of Test Structure No. 2 after shock and vibration tests. Note chip broken out of Pad No. 2 during extra blows

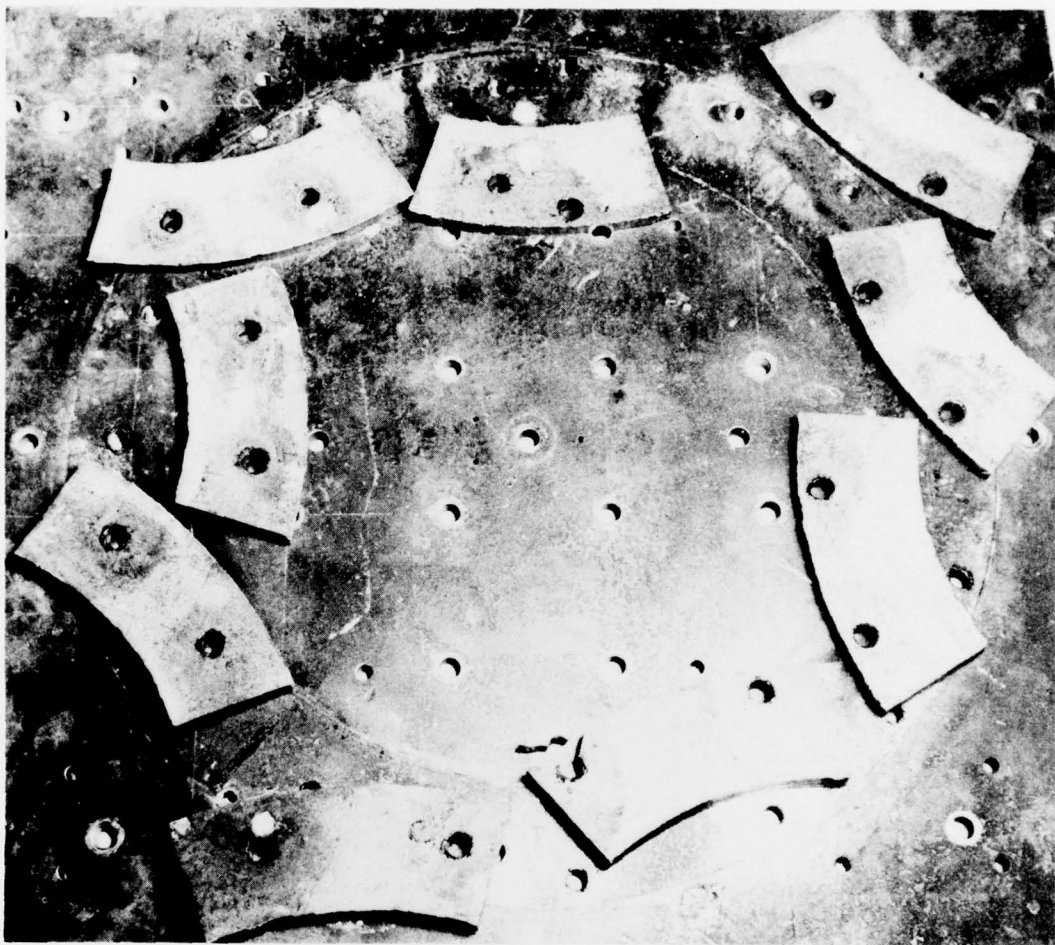
Fig. 24 — Bottom surface of chock pads of Test Structure No. 2 after shock and vibration tests
